# The Metro Trolley Overhead Program 1973 to 1981

Lynn L. Wilcox, P.E.  
Metro Technical Services Department  
821 Second Avenue  
Seattle, Washington 98104

June 1981

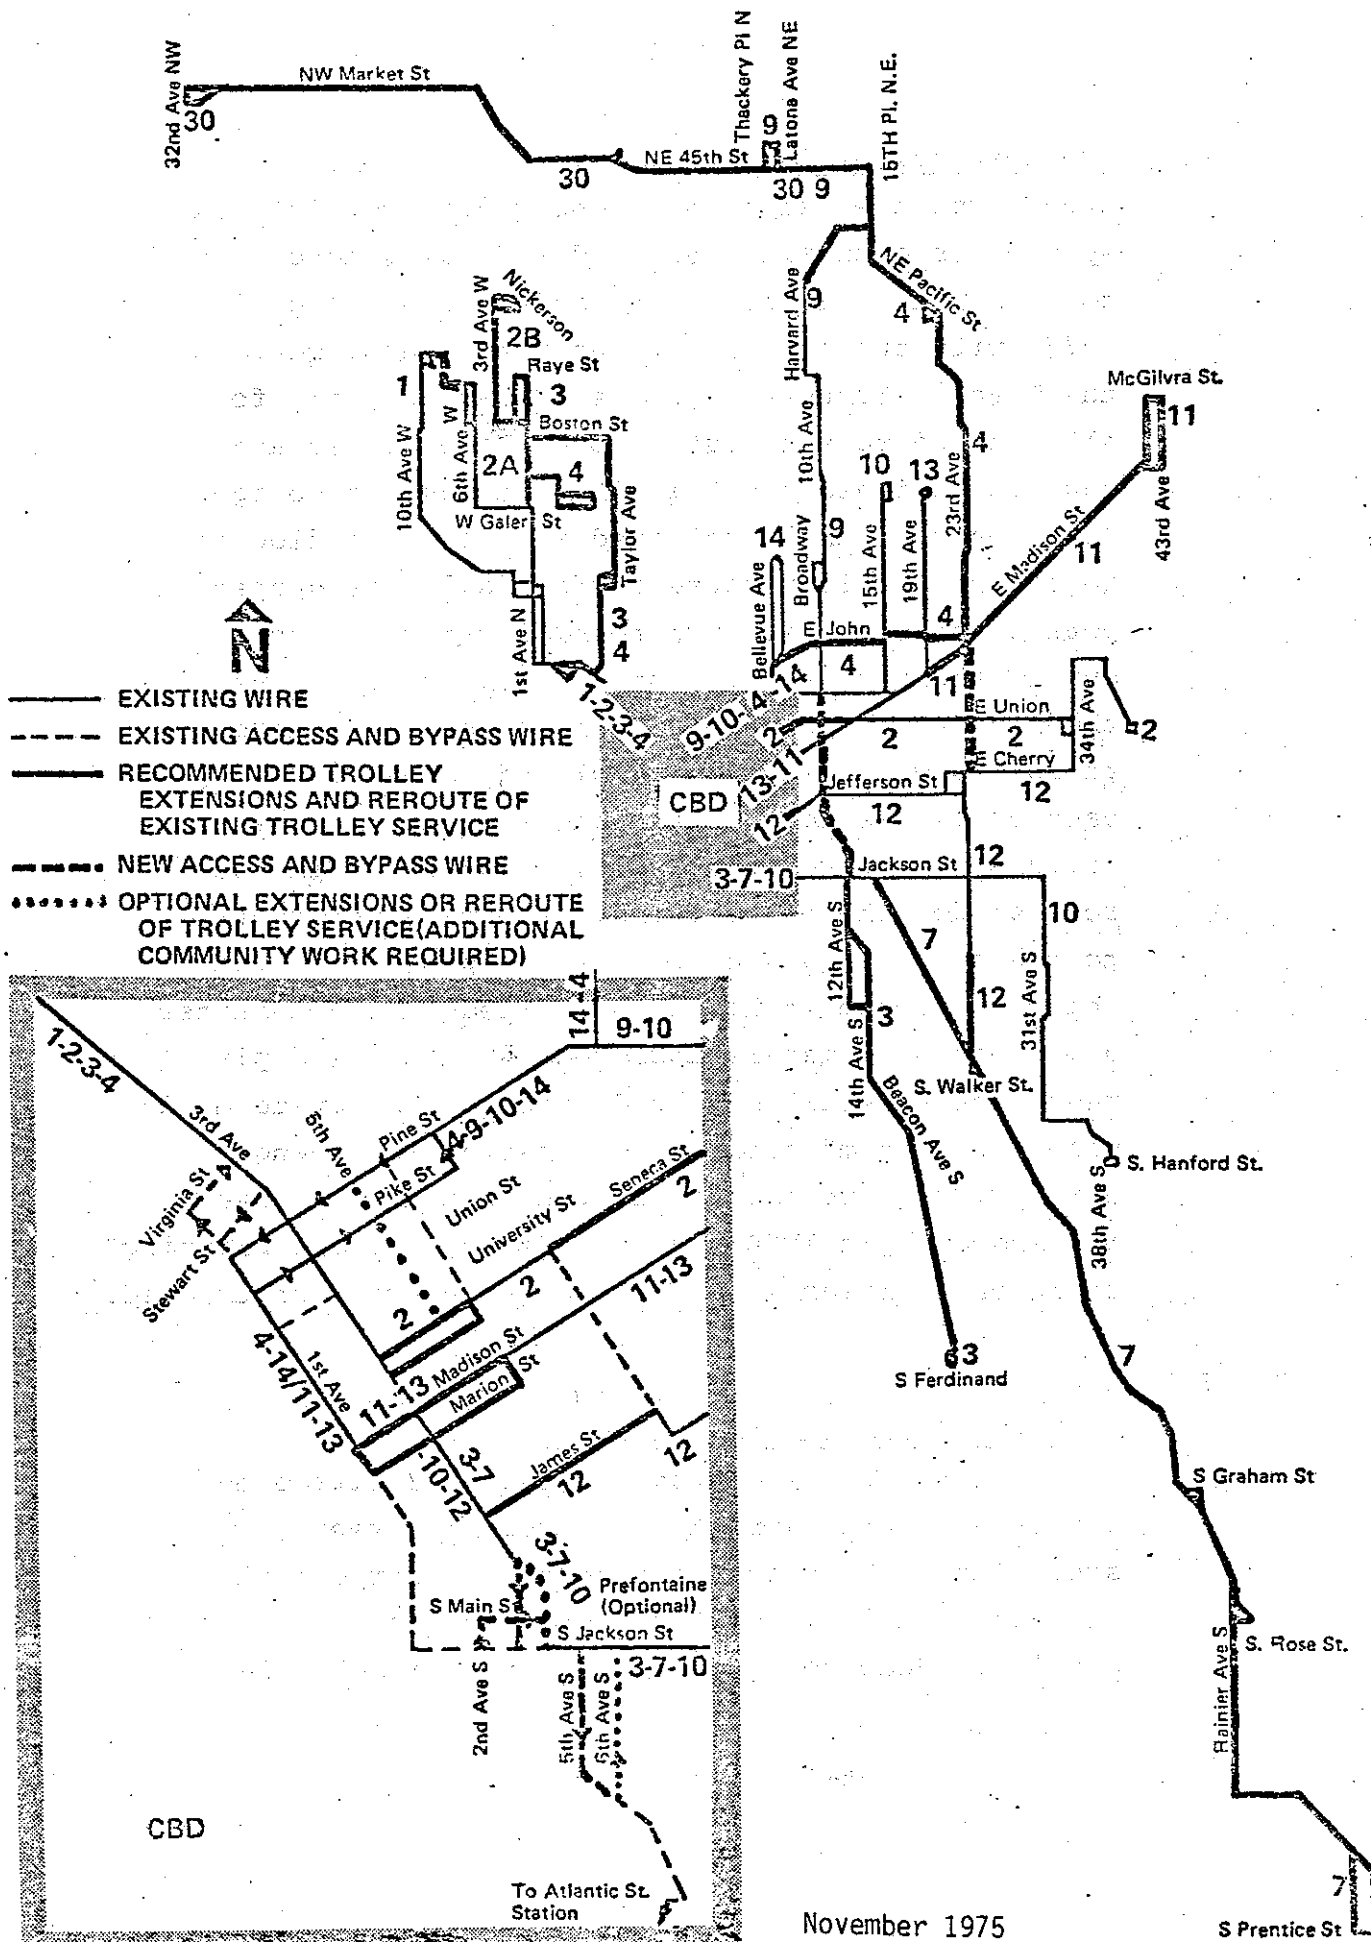
This effort led to the publication of the "Trolley Rehabilitation and Extension Plan Refinement" (5). The refined plan, which was subjected to extensive agency and public scrutiny, differed from the 1974 plan primarily in the location of routes in the central business district (CBD). The revised routes relieved trolleybus traffic on the only east-west street in the existing system, Pike Street, by providing east-west service on other streets in the CBD. These revisions were made to reduce transfers and passenger walking distances. Only minor changes were made in the wire plan outside the CBD. As a result of these proceedings, a final electrification plan was established in November 1975 (see figure II-6). The City Council approved this plan on Jan. 29, 1976.

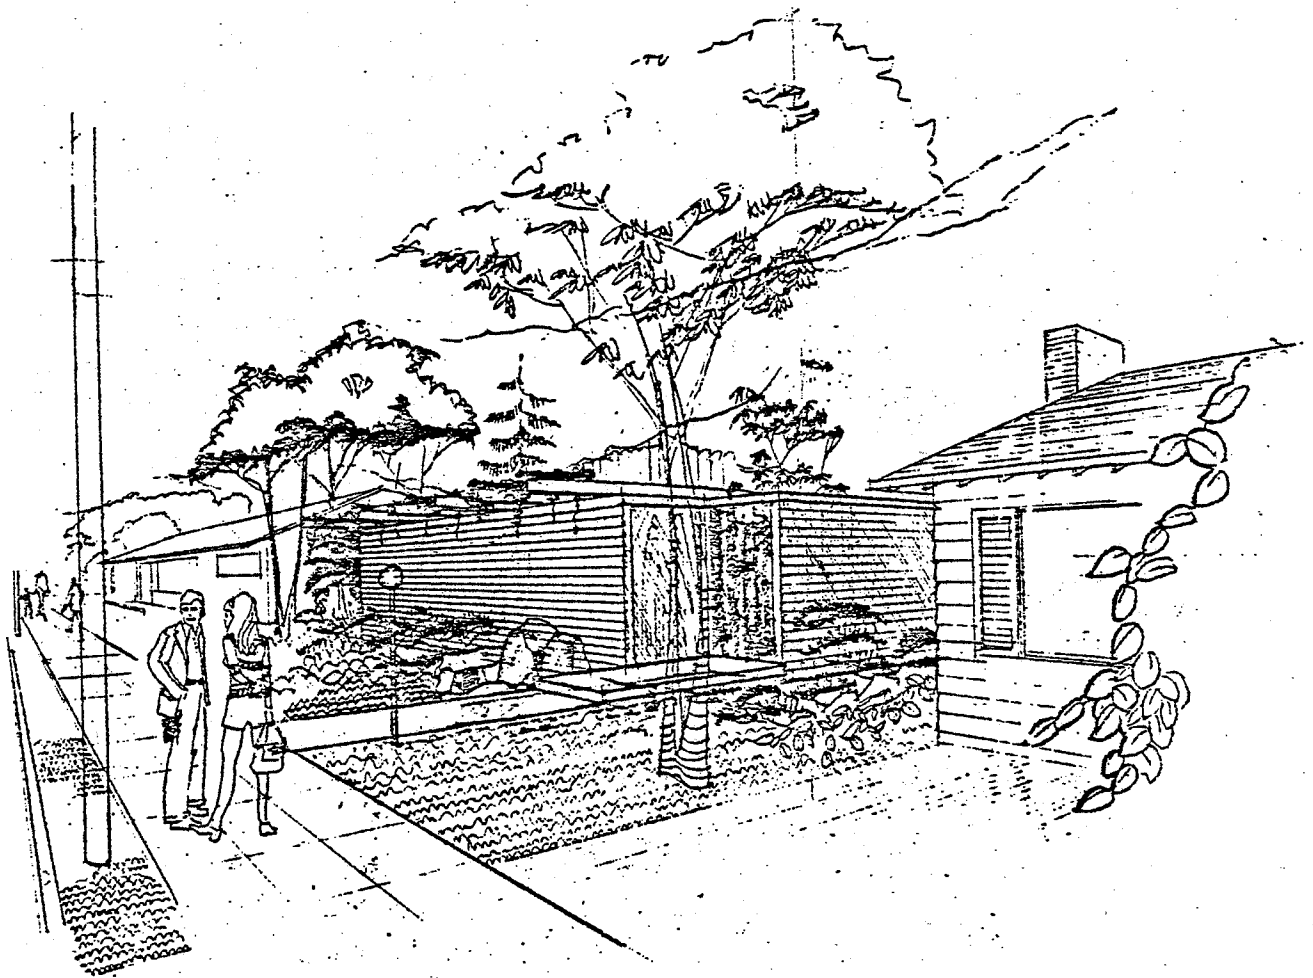
DESIGNED:	  <b>METRO</b> Municipality of Metropolitan Seattle	DATE: 4/80
DRAWN: LLW		FILE NO.
RECOMMENDED:		DRAWING NO. FIG IV-1
APPROVED:		SHEET OF

500 KW RECTIFIER SUBSTATION  
CONCEPTUAL RENDERING

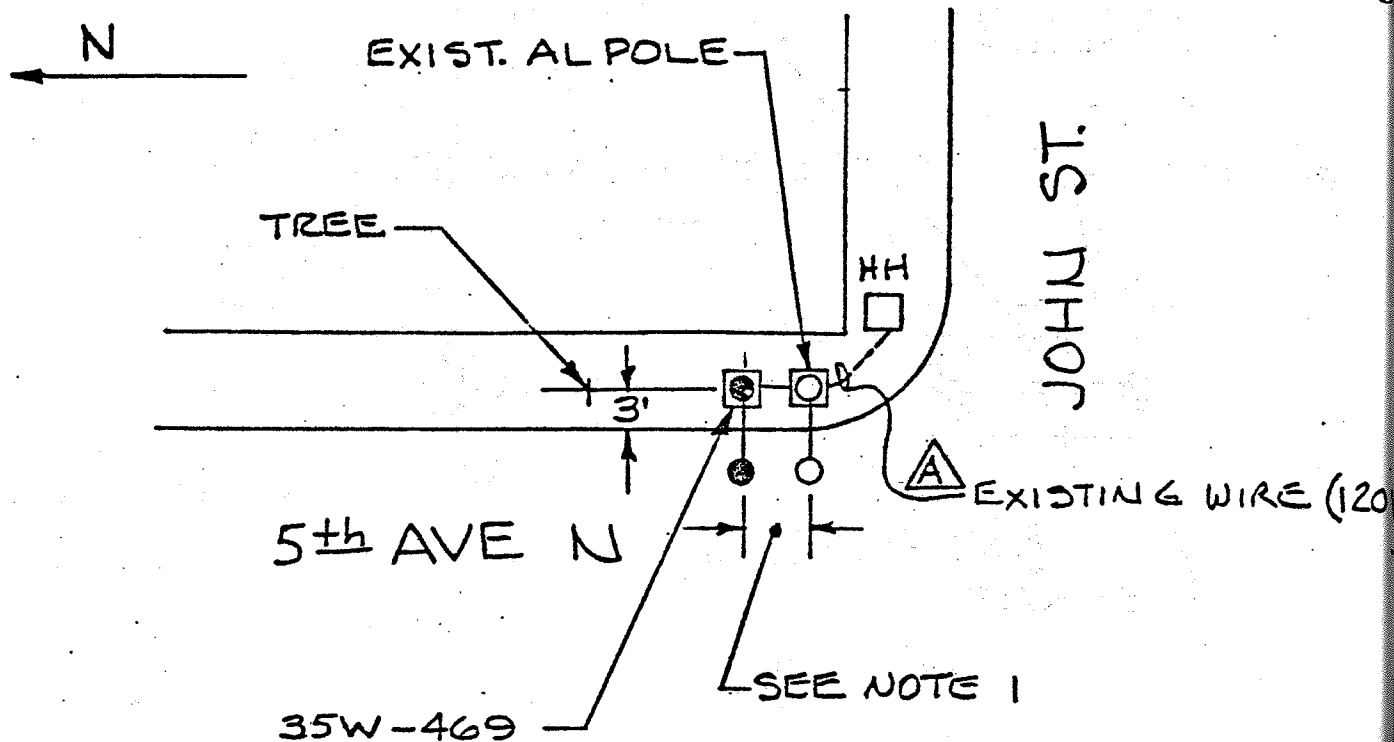
APPENDIX B2

POLE 35W-469 SAZONN(LM)  $\Delta$   
E. SIDE 5<sup>th</sup> AVE N., 1<sup>st</sup> N OF JOHN ST

1. INSTALL REPLACEMENT POLE 35W-469 AS SHOWN. PLACE BASE IN CONTACT WITH UNREMOVED PORTION OF EXISTING LIGHT POLE BASE.
2. NOTIFY C.L. TO DE-ENERGIZE CCT. INTERCEPT EXIST. CONDUIT & EXTEND INTO 35W-469. REMOVE & REPLACE EXIST. WIRE BETWEEN HH & 35W-469 WITH DUPL #6 AL / SPECS.
3. REMOVE EXIST. POLE, LIGHT & BASE & DELIVER TO CITY PER SPEC FINISH BASE 6" BELOW GROUND LEVEL.
4. CONTRACTOR TO SUPPLY 6' STANDARD ARM PROVIDED BY POLE MANUFACTURER AT 35' NOMINAL LIGHT PLACEMENT HEIGHT ABOVE GROUND LINE.

- & CONNECT
5. CITY LIGHT TO INSTALL APPROVED LIGHT PER WORK ORDER

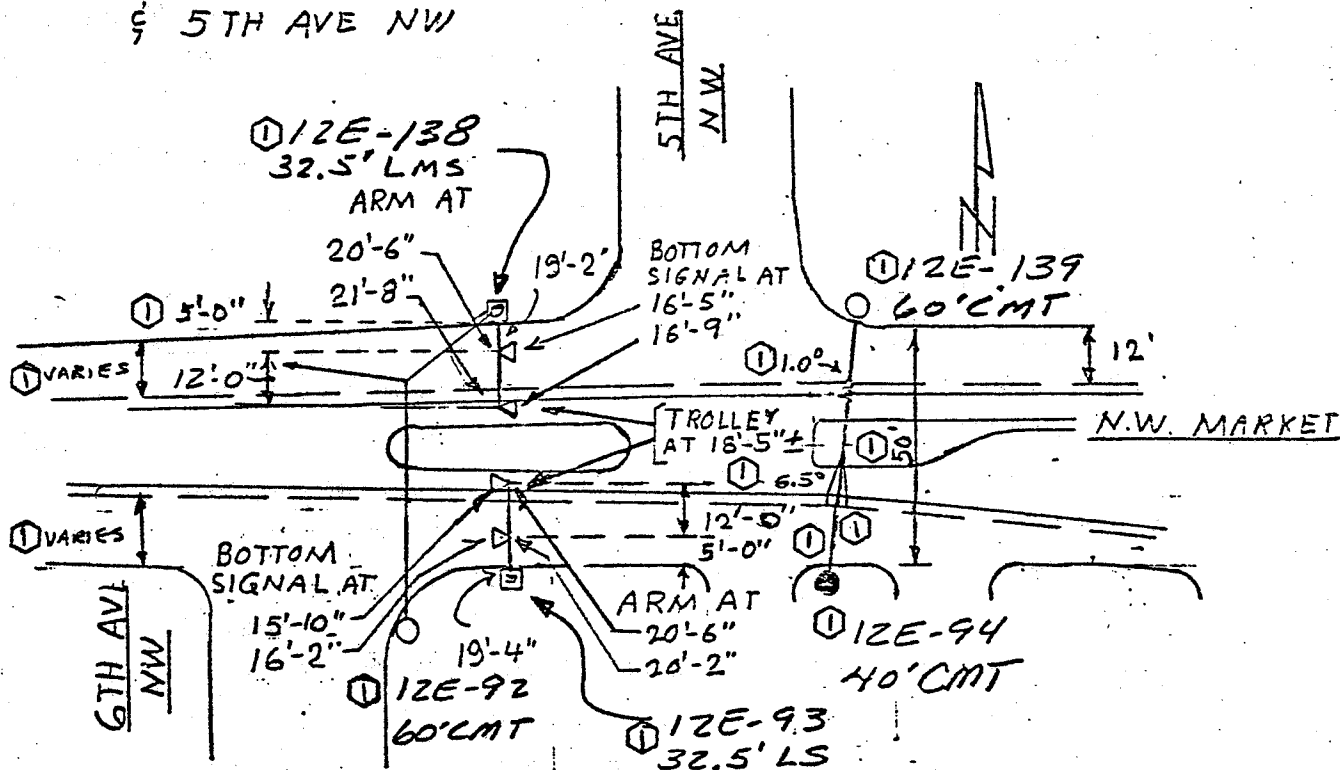
§ 5TH AVE NW

MAST ARM SIGNAL HEADS

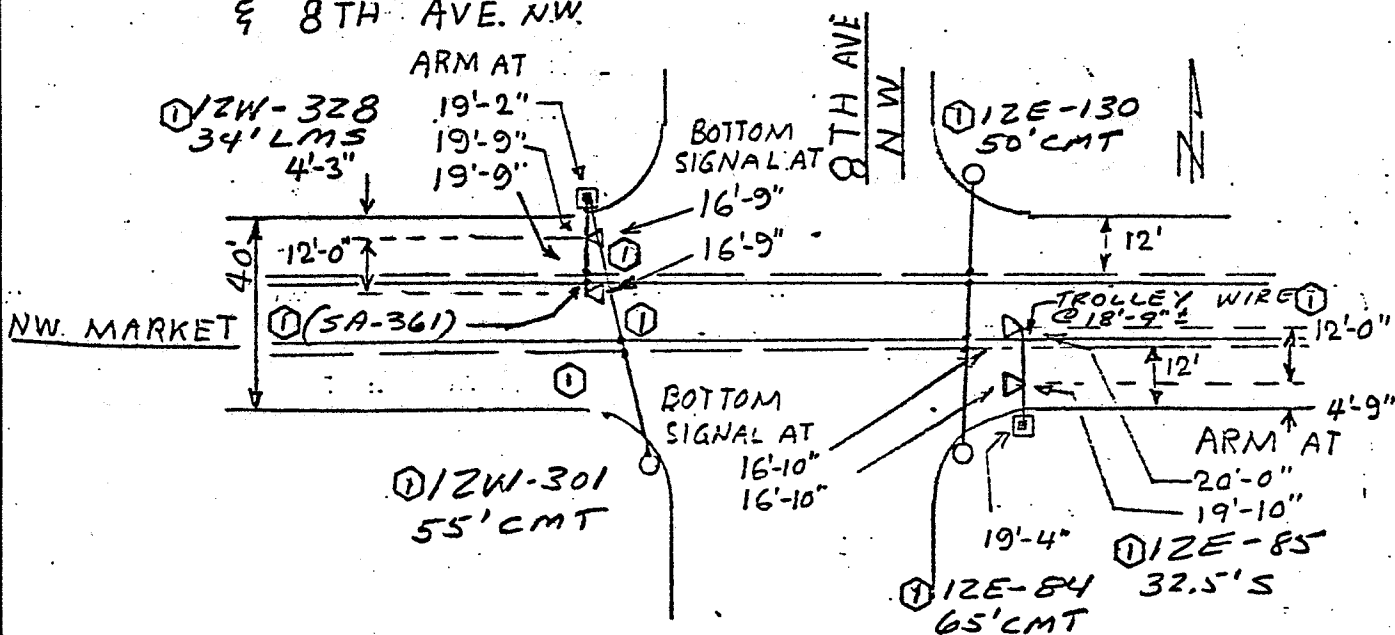
NW MARKET ST  
 & 8TH AVE. NW

MAST ARM SIGNAL HEADS
